Property Inspection Report

1541 La Maderia dr., Palm Bay, Fl. 32908
Inspection prepared for: Melvin Jones & Melvin Jones
Real Estate Agent: Anita Uhrmann - Caldwell Banker

Date of Inspection: 12/16/2014 Time: 11am
Age of Home: 8yrs Size: 2250
Weather: sunny

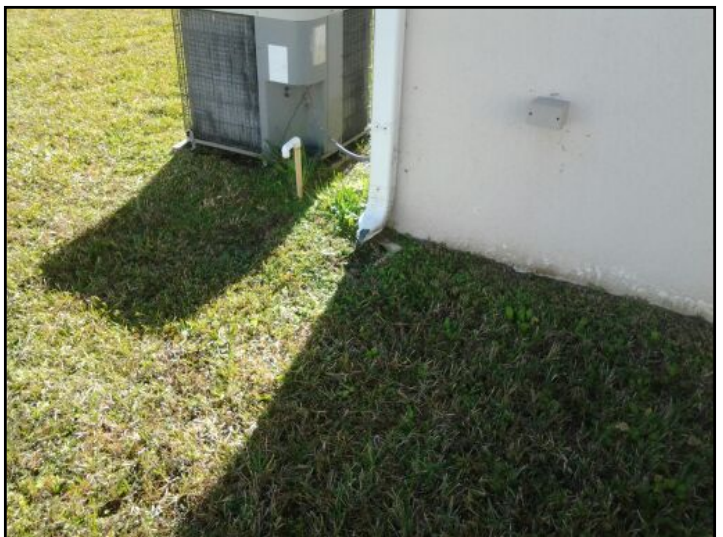
- Extensions / Splash blocks missing or insufficient: Install to divert water away from the foundation.

Roof		
Page 22 Item: 7	Gutter	<ul style="list-style-type: none"> • Extensions / Splash blocks missing or insufficient: Install to divert water away from the foundation.

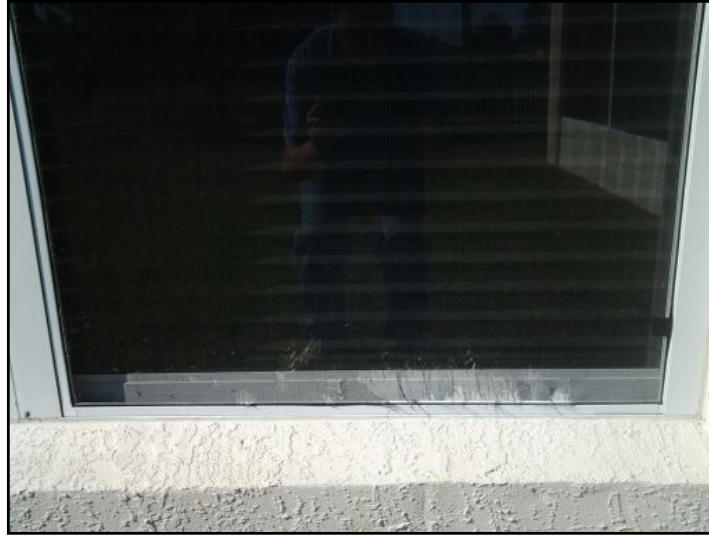
- Components appeared in satisfactory condition at time of inspection.
- Some window screens damaged.

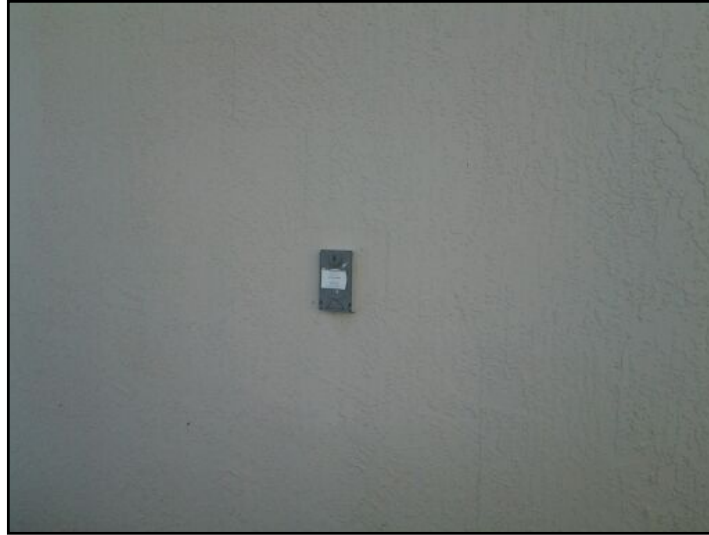
- No leaks were observed at the time of the inspection.
- There was a minor stairs step crack very minor. Monitor caulk and paint.

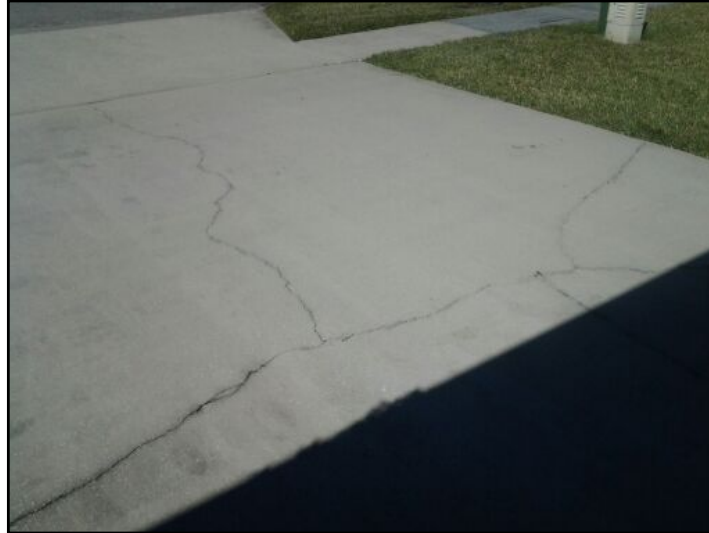
- Moderate cracks in sidewalk. Repair and / or monitor for expansion and development of trip hazards.
